**BLOSSOM PARK CONDOMINIUM  
BUILDING A & B  
LIFE SAFETY & STRUCTURAL ASSESSMENT**

**MRI. Project No.: 1424**

**02 March 2015**

**Re: BLOSSOM PARK AT 1851 W. LANDSTREET RD. ORLANDO, FL  
STRUCTURAL CONDITION OBSERVATION ASSESSMENT INGRESS/EGRESS AREAS  
SUMMARY REPORT OF ALL BUILDINGS AND STAIRS.**

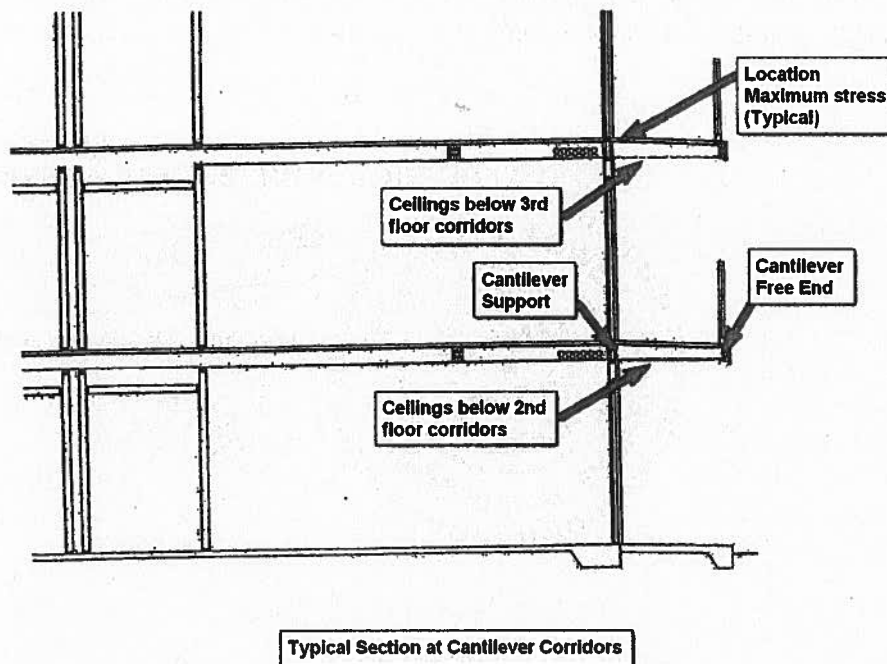
Second and third floor corridors are cantilevers made out of wood framing with concrete topping of about 1 to 1.5 inches thick. A handrail is connected at the end of the cantilever. See section below.
